SEM Diaries - 44

Excitements in the Lab

A New EDS System, and Shelves

Jeremy Poole

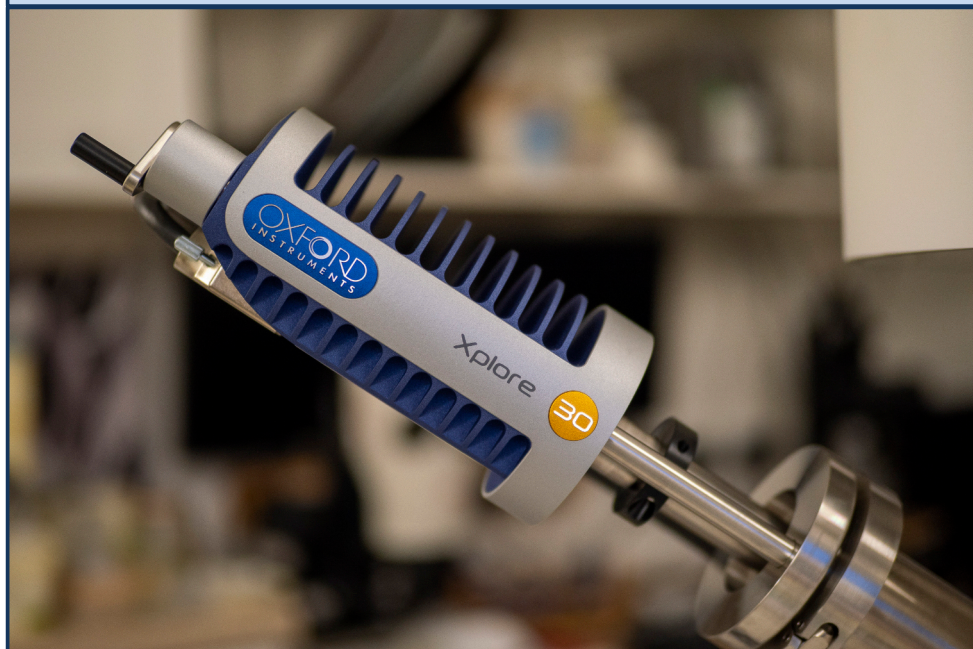
Fig. 1: The sensor for the new EDS system, projecting from the side of the SEM chamber

So, am I happy with the decision I made to buy a new EDS system? The answer is a (slightly qualified) “Yes”. The only real concern I have is that the sensor (Figure 1) is located on the front of the SEM and points into the lab. This could be vulnerable should anyone feel they could use it as a hand hold or knock it with a shoulder. Replacing it would cost “a lot of money”.

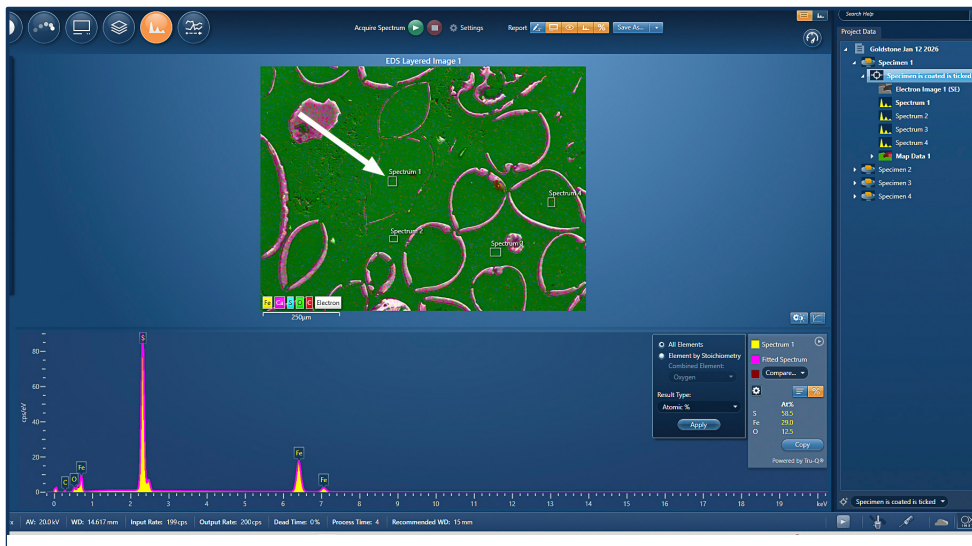
Fig. 2: A screen from the Oxford Instruments EDS software (AztecOne) showing the analysis of the iron pyrites layer of the Goldstone specimen.

An example of this analysis is shown in Figure 2. The top half of the screen displays an electron micrograph of the scanned area, false-coloured to indicate the composition of the material across the specimen. The lower half of the screen shows the spectrum of the X-ray energy emitted by the specimen at a particular location - spectrum 1, represented by a

small square (arrowed). Also in the bottom half of the screen is a box providing the results of the analysis, and this is reproduced as Figure 3.

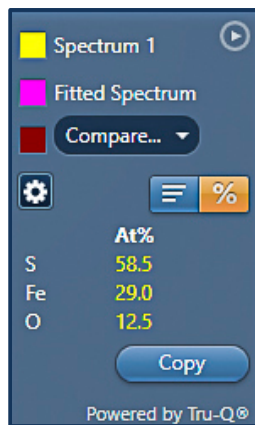
This tabulates the “Atomic” percentage of the elements that were detected over the small area indicated as spectrum 1 on Figure 3. It shows that the ratio of iron

Fig. 3: The quantitative results of the analysis of the Goldstone sample showing the ratio of iron to sulphur of 29:58.5, which is within system error of 1:2, as expected.

atoms to sulphur atoms in the sampling area is a very good approximation to 1:2. This is the result that was determined by my contact at PEMC and confirmed that my new system provides results I could trust.

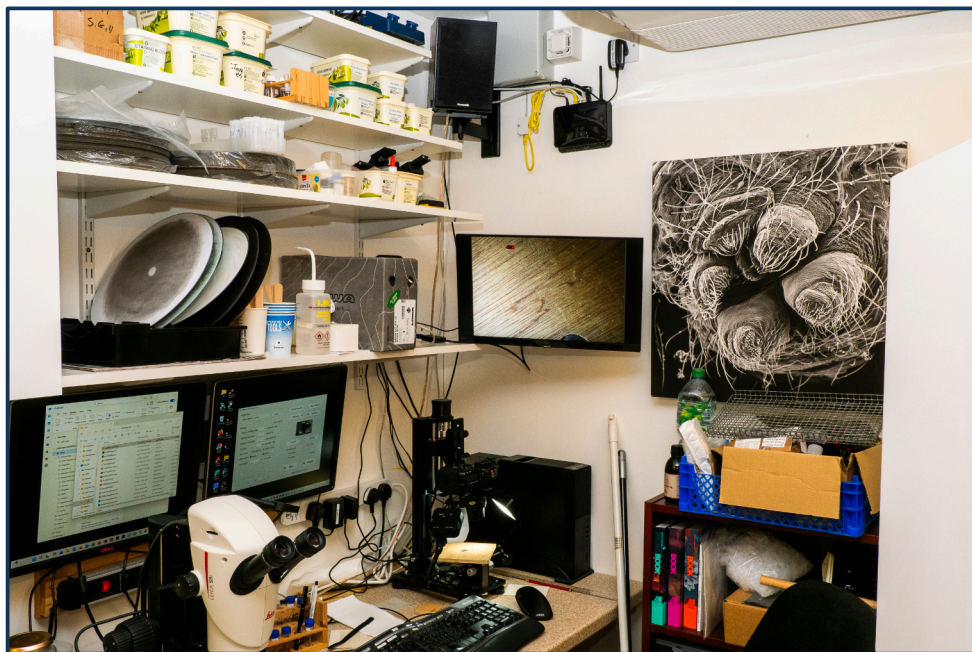
Fig 4: The shelves above the (currently tidy) optical microscopy desk. Note the relocated speaker and monitor. The sloping discs (centre left) are for holding abrasives for the polisher used to prepare rock samples for analysis.

involved fitting four shelves above the desk I use for my light microscopy (Figure 4). I carried out this work over a weekend, without any help. This was a slightly dangerous undertaking. On at least two occasions descending from a stepladder took place in a less than controlled manner and within close proximity to the expensive sensor previously mentioned!

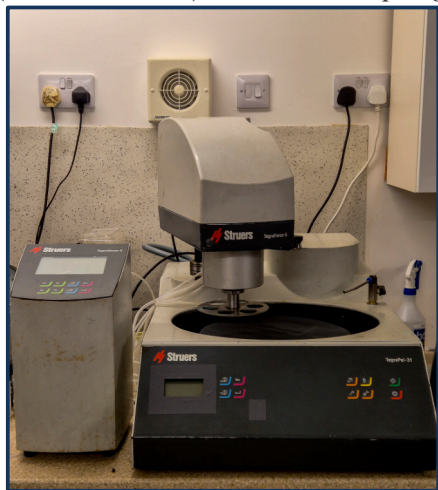
Fig. 5: The replacement polisher. The unit on the left is the doser for providing measured volumes of diamond suspension.

and upgraded. The difference between the two units is that the new one has a larger platen and is more generally robust (Figure 5). It also has a system for dripping pre-specified doses of diamond suspension onto polishing cloths for the final stages of preparation. One disadvantage is that it weighs 70 kg, so when I got it home it remained in the luggage area of my car until I could persuade a friend to help me transport it from the car to the bench in the lab!

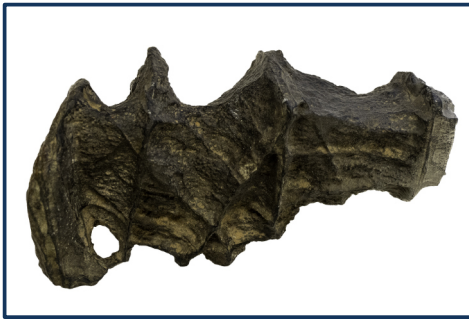
Fig. 6: The specimen as loaned to me for analysis. Overall length approx 7". I cut off a small sample at the right hand end, for embedding and polishing.

I was approached recently by a member of our local U3A Geology group with a specimen that a friend had recovered from the River Taw in Devon. It was an interesting shape, and given the somewhat “sharp” edges, was most unlikely to be very old. My first guess was that it might be molten iron from a foundry that had been quenched in water, but its specific gravity was a little over 3, so nothing like as dense as pure iron, whose S. G. is about 7.8.

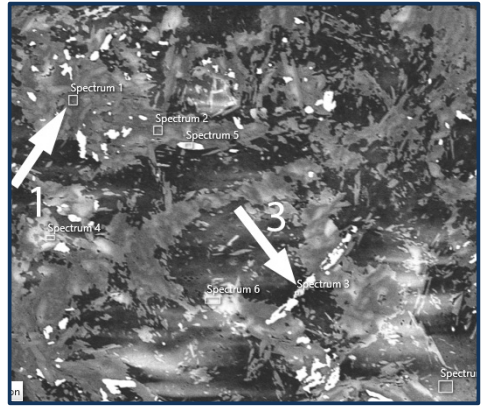
Fig. 7: An electron micrograph of the polished surface showing the areas where analysis was carried out - made using the repaired BSED.

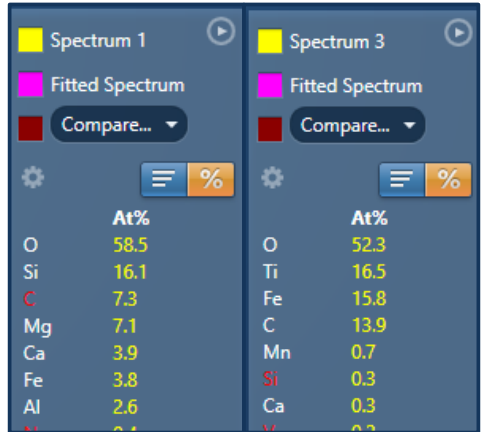
Fig. 8: Showing analysis at two locations. Spectrum 1 is high in silicon and oxygen, suggesting a high silica content. This could be remnants of sand used for casting. Spectrum 3 has a similar amount of oxygen, but no silicon. It also contains metals, namely iron and, interestingly, some titanium. The current best guess for the composition of this area is ilmenite.

The following figures illustrate the appearance of the specimen, and an analysis of the composition at a couple of locations. I ran this past a geologist friend and his first reaction was that it is likely to be iron slag. He did suggest that I see if it attracts a strong magnet, but when I tried this there was no trace of magnetic attraction. This makes the likelihood of its being iron slag less likely, although does not rule it out. He then commented on Spectrum 3, saying that perhaps the bright areas were most likely to be ilmenite (FeTiO_3). So, at this stage we do not have a definitive answer as to what it is, but there are some ideas, and I can analyse further spots to see if that sheds further light on the subject. One thing all parties are in agreement on is that the specimen was created as a result of human activity.
